Summary Report Enhanced Evaporation Pilot Test

**Anaconda Mine Site
Yerington, Nevada**

Summary Report - Enhanced Evaporation Pilot Test

Yerington Anaconda Mine Site

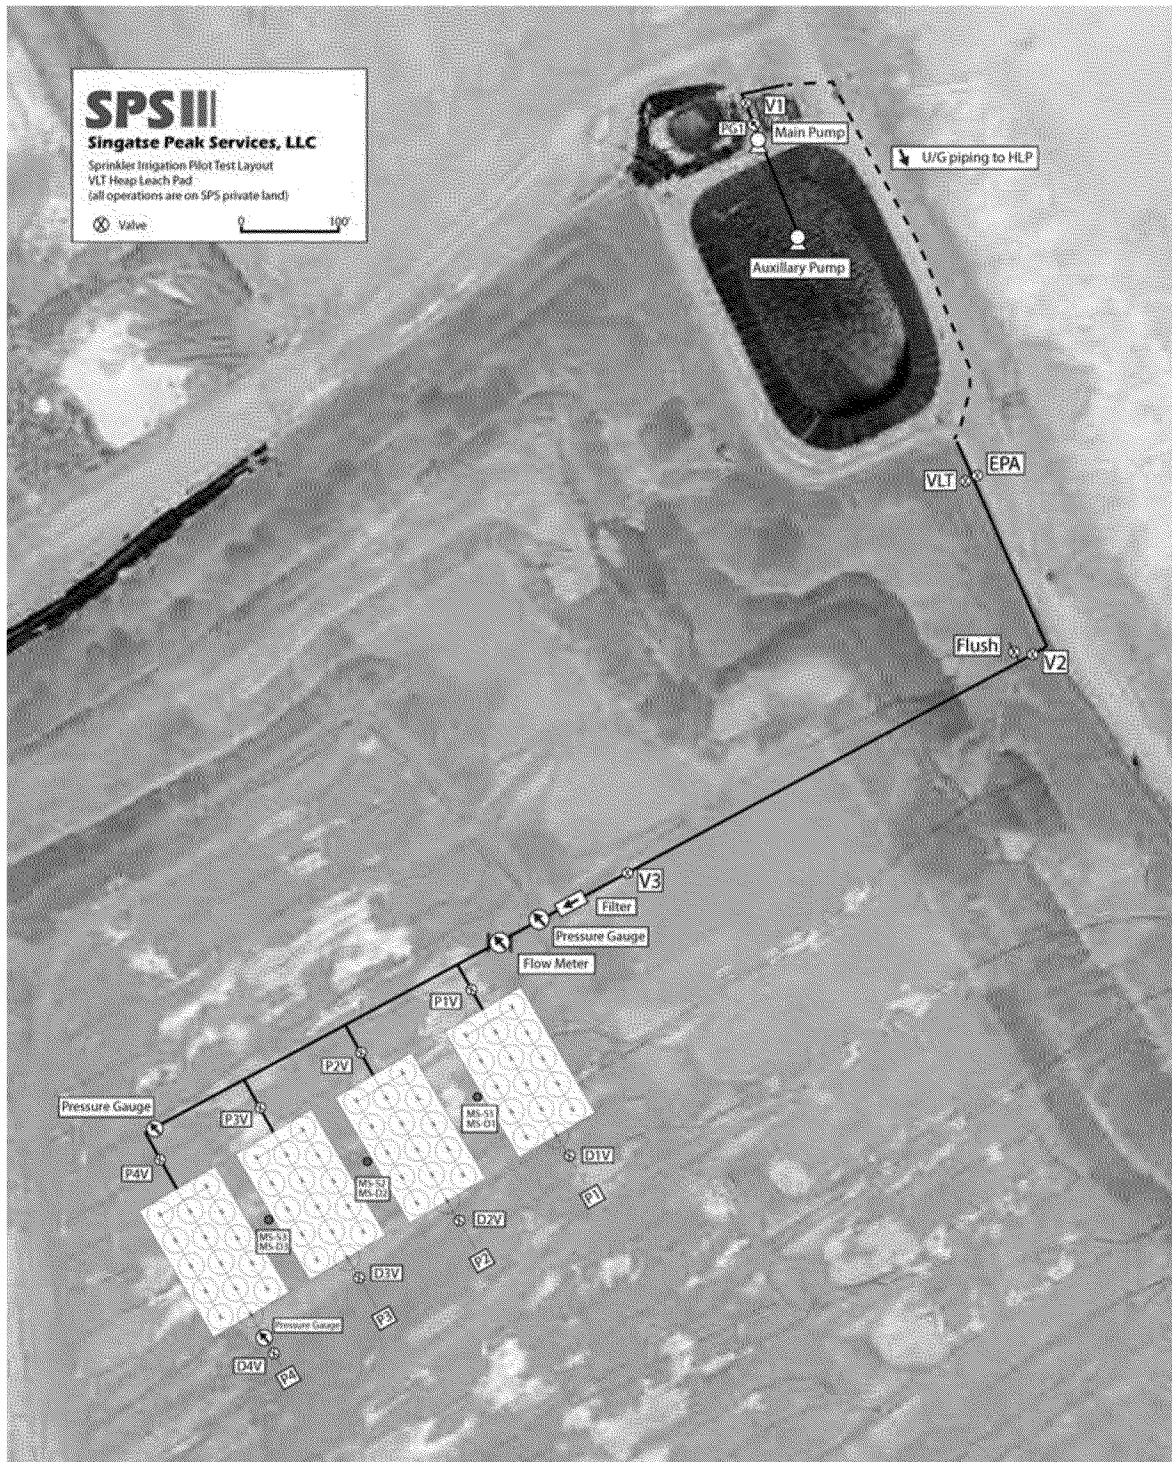
Figure 4-1. Enhanced Evaporation Pilot Test Layout

All operating pressures of the pilot test were designed to be well within the pressure specifications of the sprinkler head, existing and new piping, and other components of the system. The operating pressure at the sprinkler heads was designed to be between 30 and 40 psi. To account for head losses in the piping and the elevation change between the pump and the sprinkler heads, the operating pressure at the discharge side of the Durco pump was set between 120 and 140 psi. This allowed for approximately 90 to 100 psig pressure to account for the difference in elevation between the VLT pond and the top of the VLT HLP. The design rates were provided as a range to account for uncertainties associated with pumping high TDS (and therefore high specific gravity) FMS fluids. In addition, a bypass valve and associated piping were added to the discharge side of the main pump that functioned to allow for variable flow at constant pressure. The system layout is shown on Figure 4-1.

The VLT HLP was selected for the pilot test because piping was already in place and the top of the VLT HLP is relatively level, requiring minimal site preparation to accommodate the pilot test. Based on the pump and sprinkler specifications, the evaporation panels were designed to be 90 ft wide by 150 ft long. Using four panels, this resulted in a total of 60 sprinkler heads, each putting out approximately 2.4 gpm at 40 psig. The estimated diameter of coverage at each sprinkler head was 30 ft and the design also allowed for 30 ft between each panel. This provided an effective area of the pilot test of 67,500 ft² (approximately 1.5 acres).

The existing 4-inch HDPE pipe was used from after the discharge side of the main pump from where the piping goes underground up to the top of the VLT HLP. New SDR 11 piping was installed on top of the VLT HLP. Piping in the new panels on top of the VLT HLP was designed with 2 inch HDPE pipe. The sprinkler riser pipe was designed with Schedule 40 PVC. The piping and valves were designed such that between one and four panels could be operated at the same time allowing for operational and maintenance flexibility without shutting down the entire system. It was demonstrated during startup that all four panels could be efficiently operated at the same time. Flow meters and pressure gages were installed at key points in the system. An in-line filter was installed in the 4-inch diameter pipe at the top of the HLP upstream of the sprinkler manifold.

The piping and sprinkler layout is shown in Figure 4-1. Manufacturer data sheets and specifications of the equipment used for the pilot test are provided in Appendix A. The sequence of construction was as follows:
